# Manhole Inspection Summary

Manhole # S23YY\_007MH

**Location** Address: **3429 CLIPPER MILL RD**

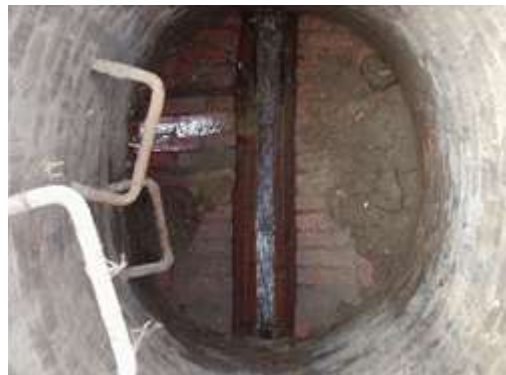
Top View

Corroded steps. Evidence of surcharge - Bench debris.

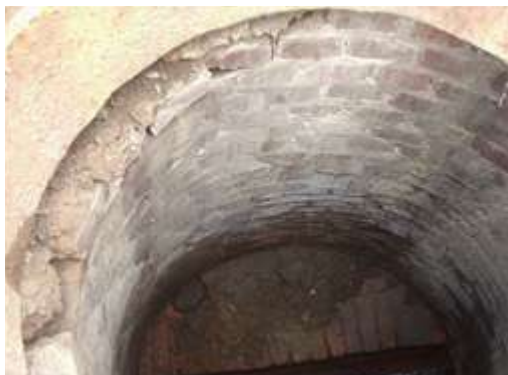
Defect

Frame leaks. Frame offset. Adjustment deterioration, loose brick and infiltration. Barrel infiltration - other side.

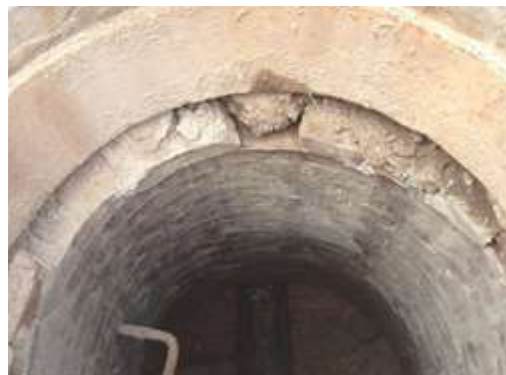
Defect

Frame leaks. Frame offset. Adjustment deterioration, loose brick and infiltration. Barrel infiltration.

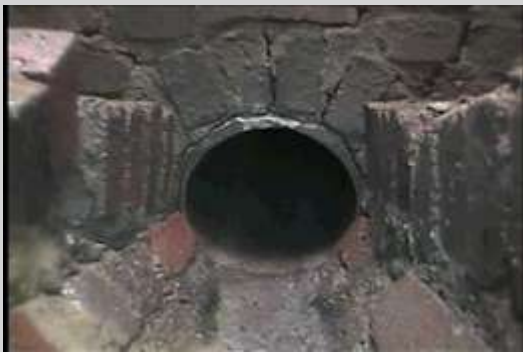
### 8 in. Circular Gravity Sewer Pipe Out @ 12 O'Clock

Barrel deterioration and infiltration. Channel deterioration.

Infiltration: **Evidence** Pipe Seal Cond: **Cracked**
